POPPLETON HISTORIC STUDY

B-2567

<u>Block</u>	<u>Lot</u>	<u>Address</u>
200	98-101/103	1034-1040 W. Fairmount Avenue

B-2567
1034-1040 W. Fairmount Avenue
Block 0200, Lots 98-101/103
Baltimore City
Baltimore West Quad

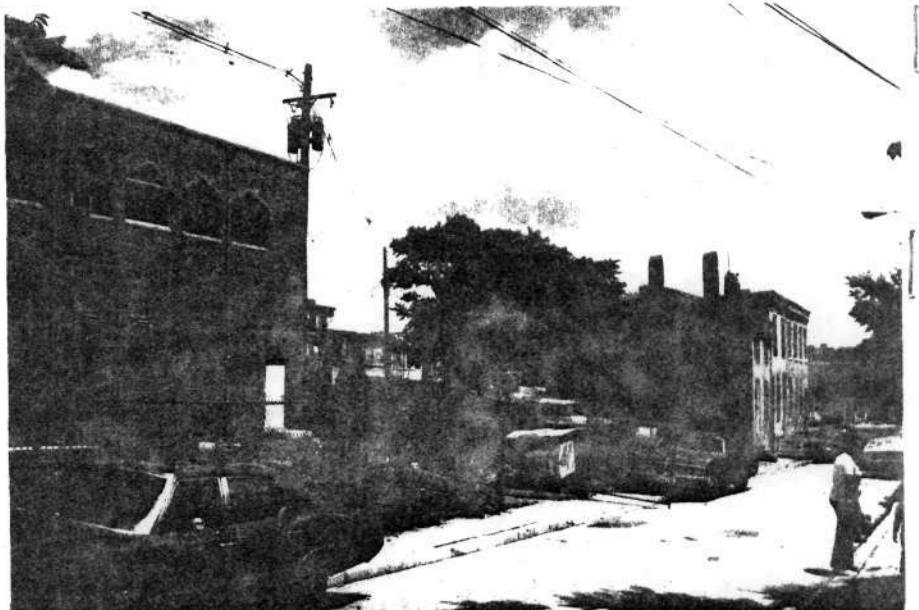
Numbers 1034-1038 are 2-story flat houses with cellar entrances. There is a sallyport between 1038 and 1040. Number 1040 is a 2-story gable with segmental window arches. Numbers 1034 and 1036 have been formstoned.

Numbers 1034 and 1036 are vacant. The group is adjacent to the former site of the iron works and saw mill. A junkyard remains opposite on the former site of the old marble works, where a hoist and other remnants of the works can still be seen. Surrounded by cleared or open land, these houses are so isolated and disconnected that their fate depends entirely on a redesign for this block.

DEMOLISHED
